Fraunhofer Institut für Windenergie und Energiesystemtechnik IWES

07.12.2017

Effective Prevention of Rain Erosion on Rotor Blades

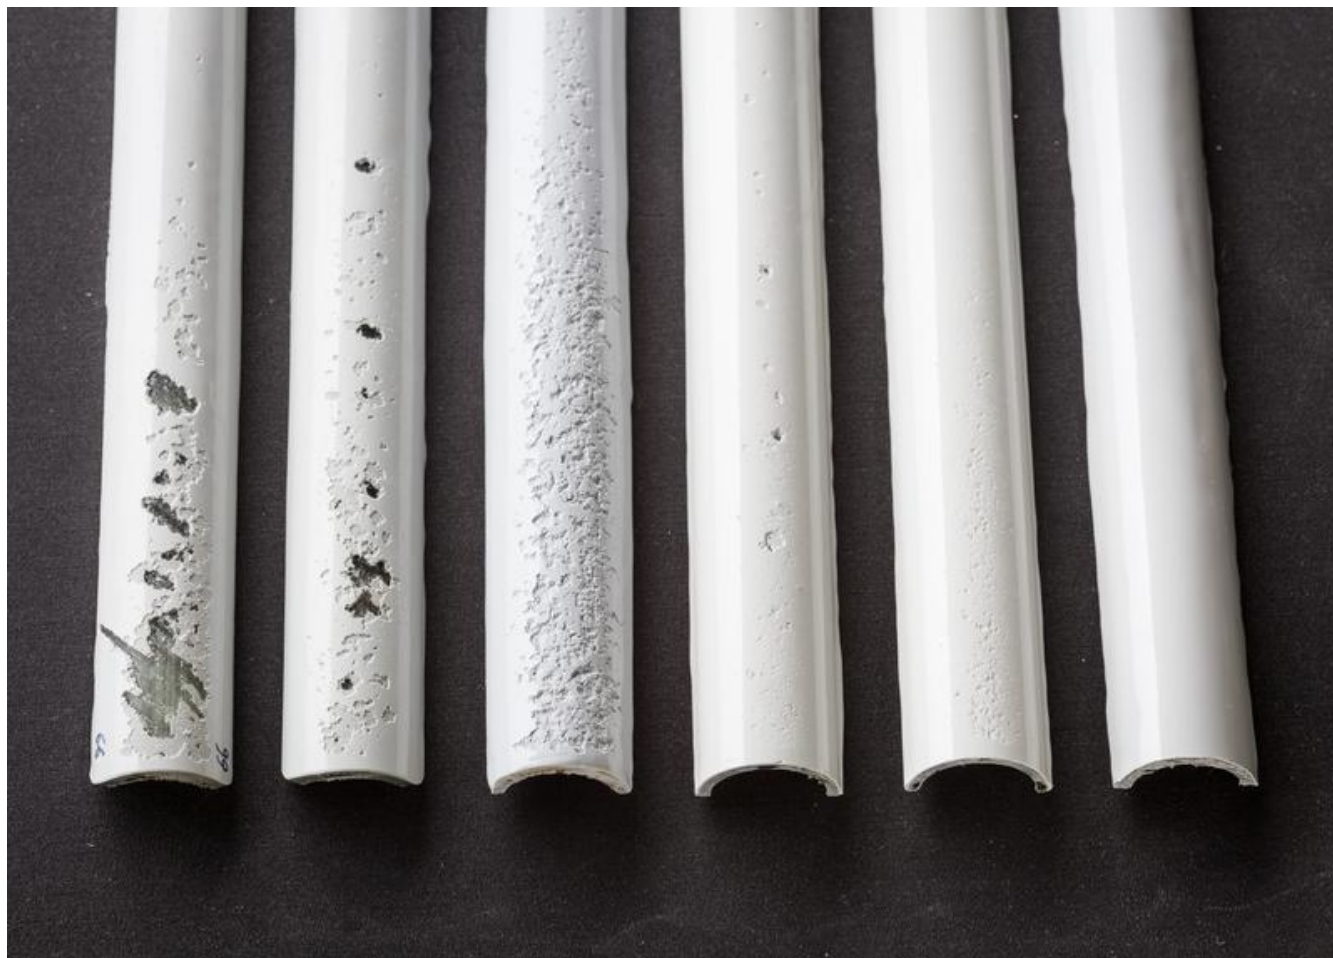
Comparison of material samples with different coatings after the rain erosion test.
Photographer: Jan Meier

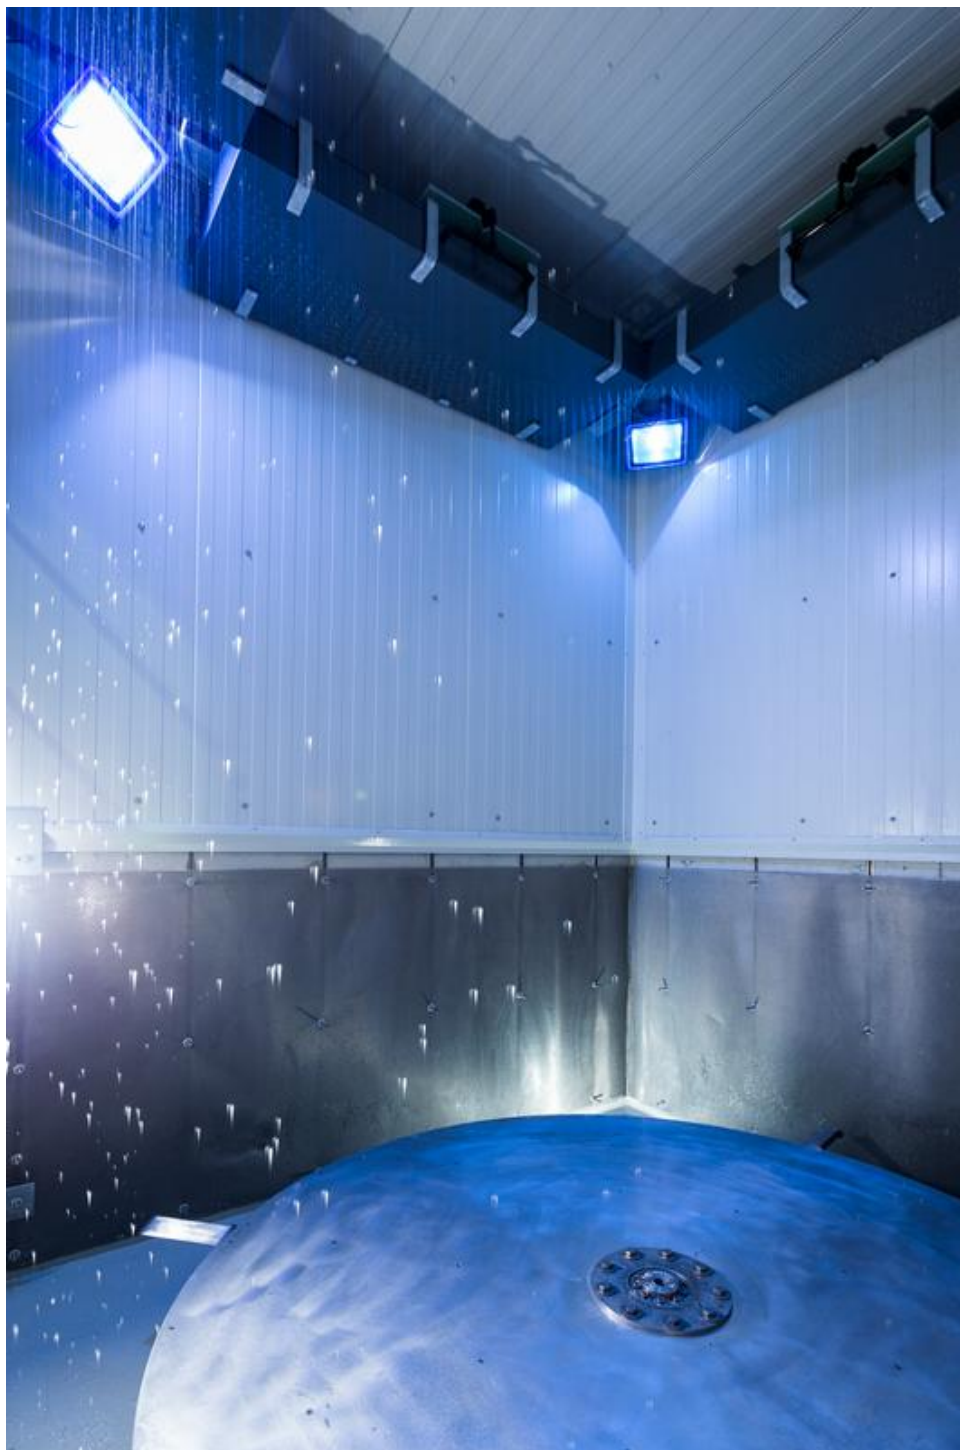
Material samples are tested with variable rotating speeds, drop sizes, water quantities, and temperatures on the rain erosion test bench.

Both the amount and size of the drops as well as the timing and frequency of their impact can be regulated precisely on the rain erosion test bench. Moreover, over the course of the 3-year BeLeB project, a drop impact system will measure exactly where the drops hit and the damage they cause. The entire test bench is modeled for this with the aid of a CFD simulation. A laser-based inspection system and a high-speed camera are used to document the damage, whereby both the topology of the sample and damage in the micrometer range are recorded. The development of an adequate material and damage model will improve understanding of the processes at material level. For material suppliers, both these aspects are of great interest for rotor blade production so as to enable them to adapt their products to the practical requirements in the best possible way.
